Technology Report 77-2

THE BROWNS FERRY NUCLEAR PLANT FIRE

ANDREW J. PRYOR
U.S. Energy Research
and Development Administration
Albuquerque, New Mexico

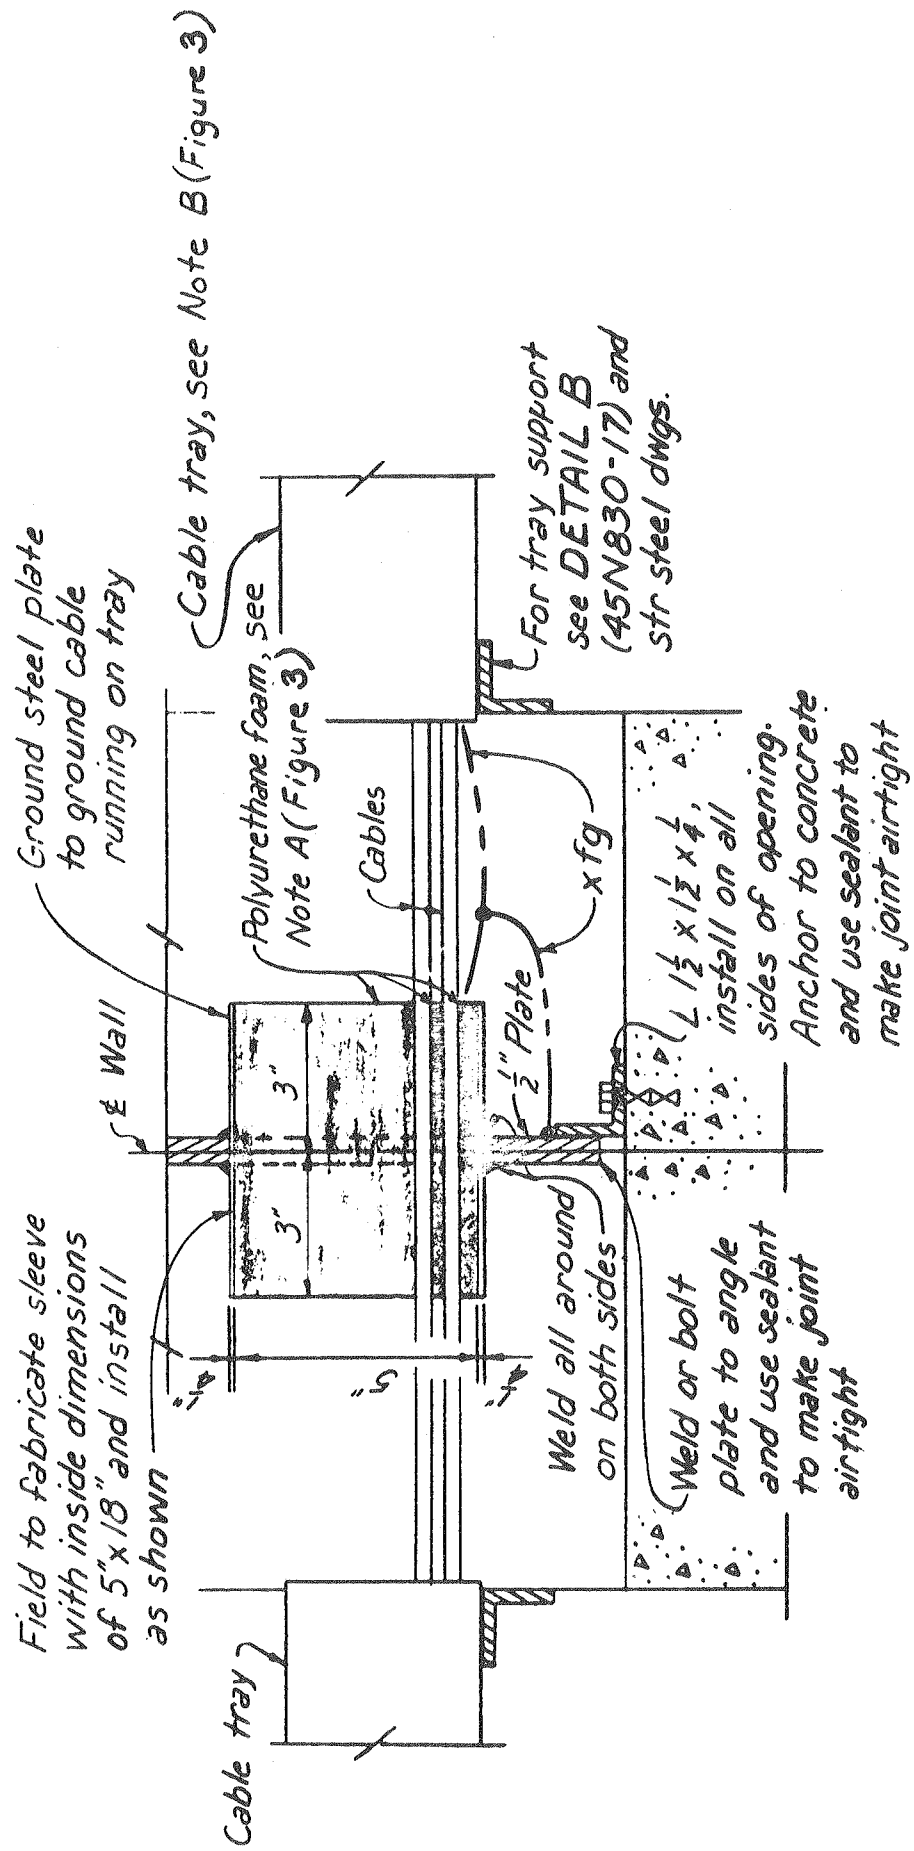
FIGURE 9
SIDE VIEW OF WALL CABLE TRAY PENETRATION
DIFFERENTIAL PRESSURE SEAL AND FIRE-
STOP DESIGN

NOTE: FIRE STARTED IN SECOND
PENETRATION FROM BOTTOM - TRAY VE

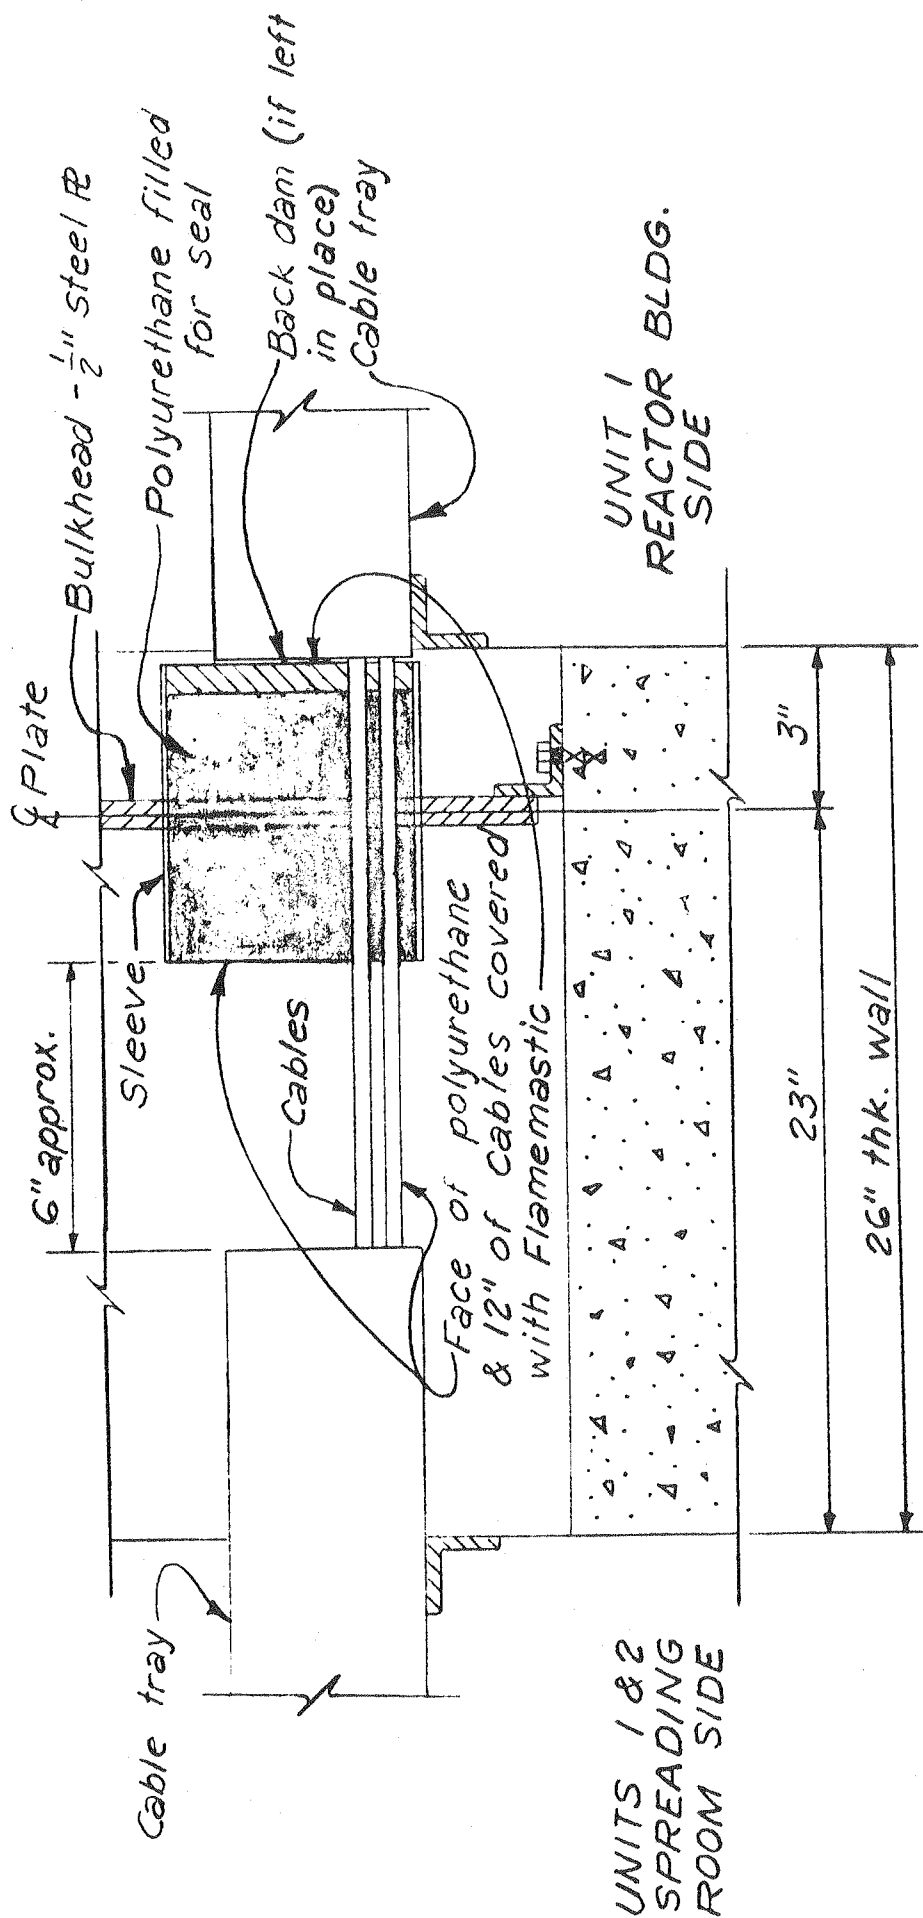
**PARTIAL CROSS SECTION OF PENETRATIONS
(TO SHOW BULKHEAD LOCATION IN WALL AS CONSTRUCTED)**

FIGURE 10
SIDE VIEW OF WALL CABLE TRAY PENETRA-
TION DIFFERENTIAL PRESSURE SEAL AND
FIRESTOP AS INSTALLED

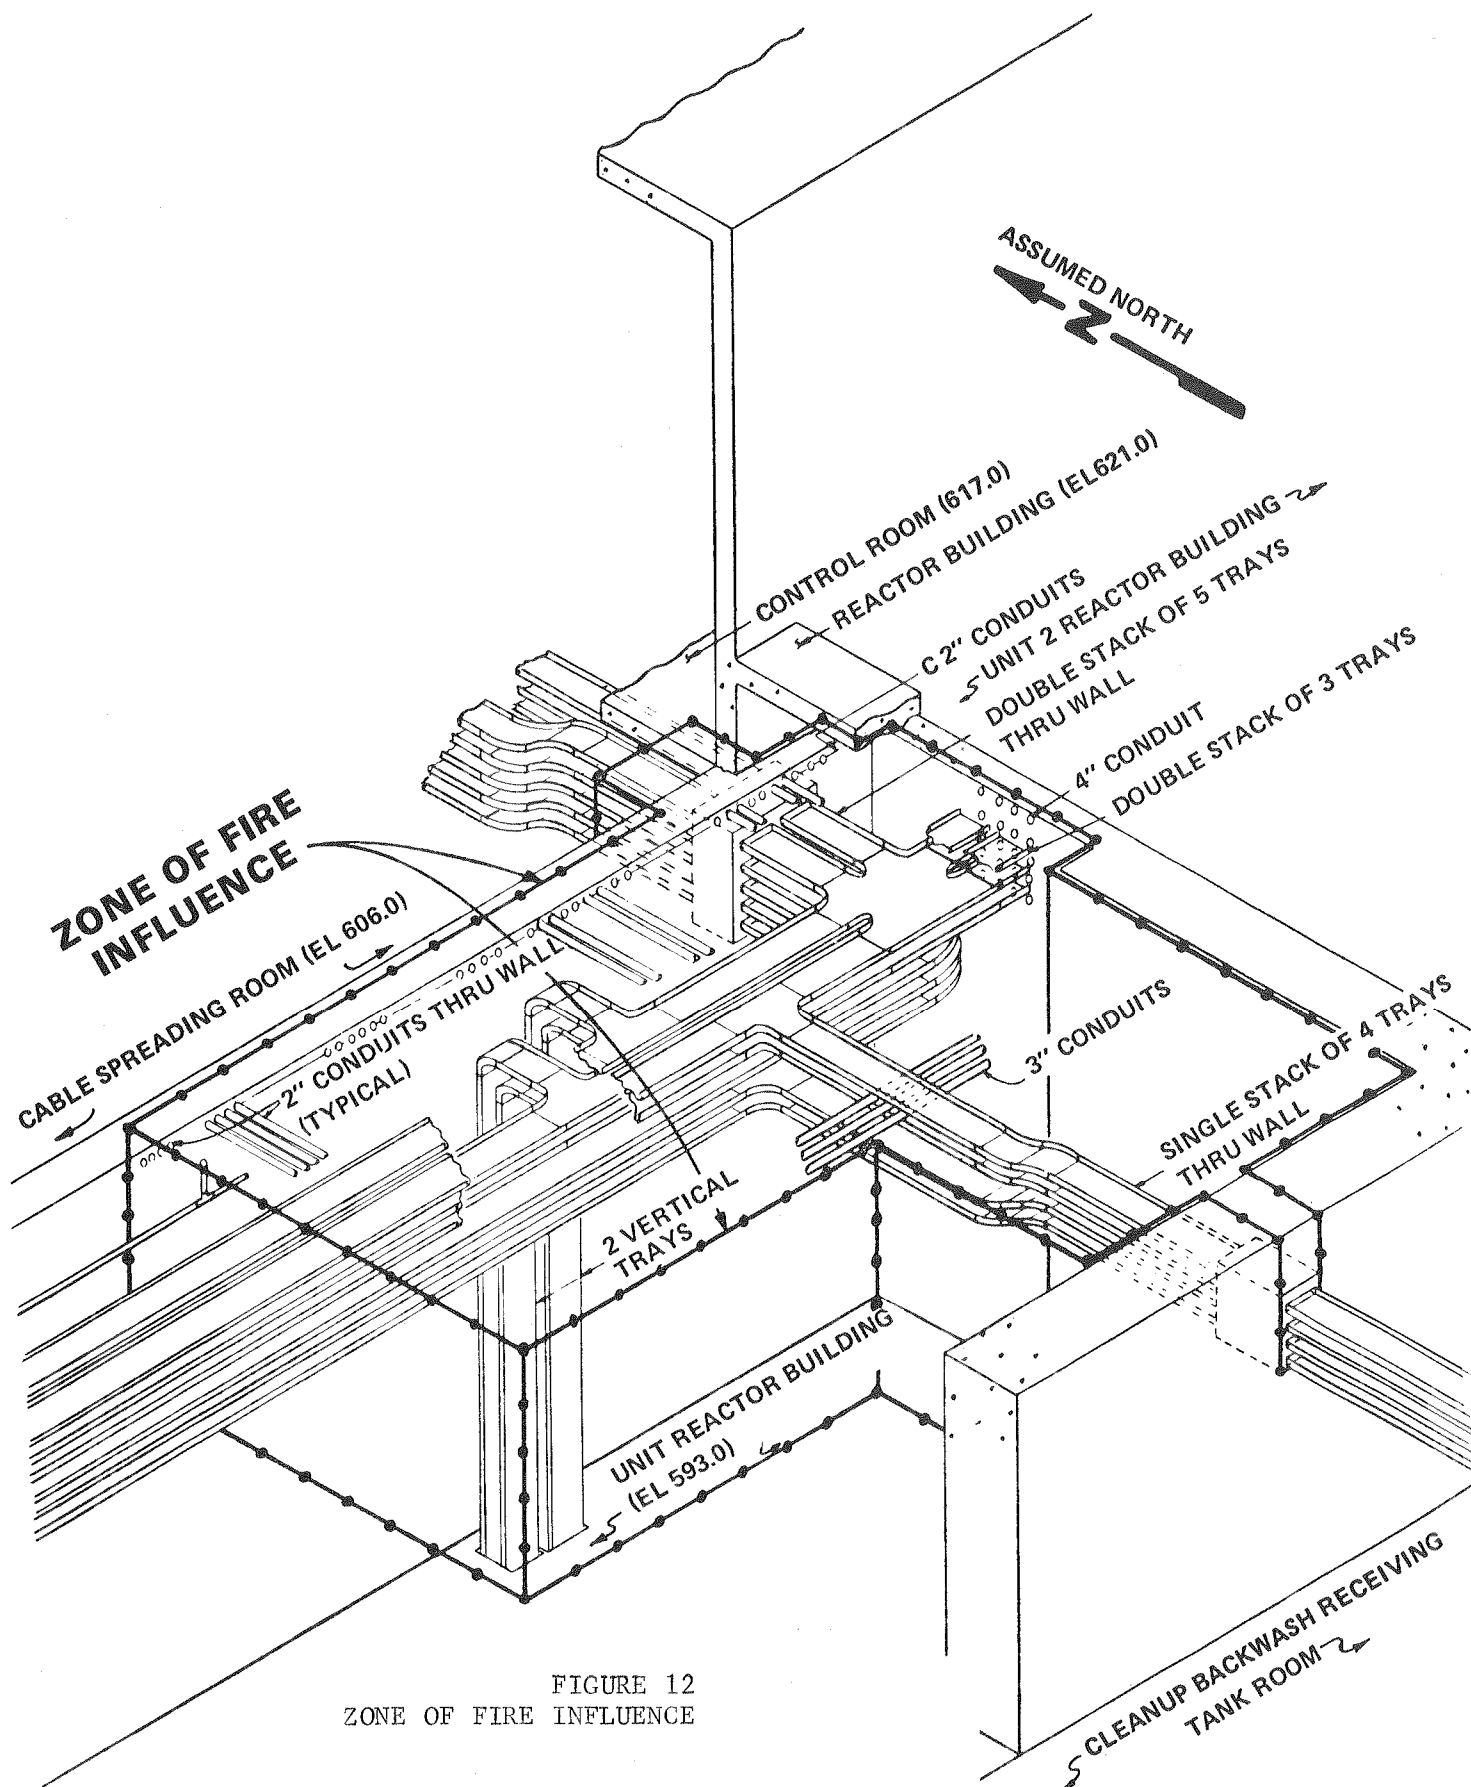
FIGURE 12
 ZONE OF FIRE INFLUENCE

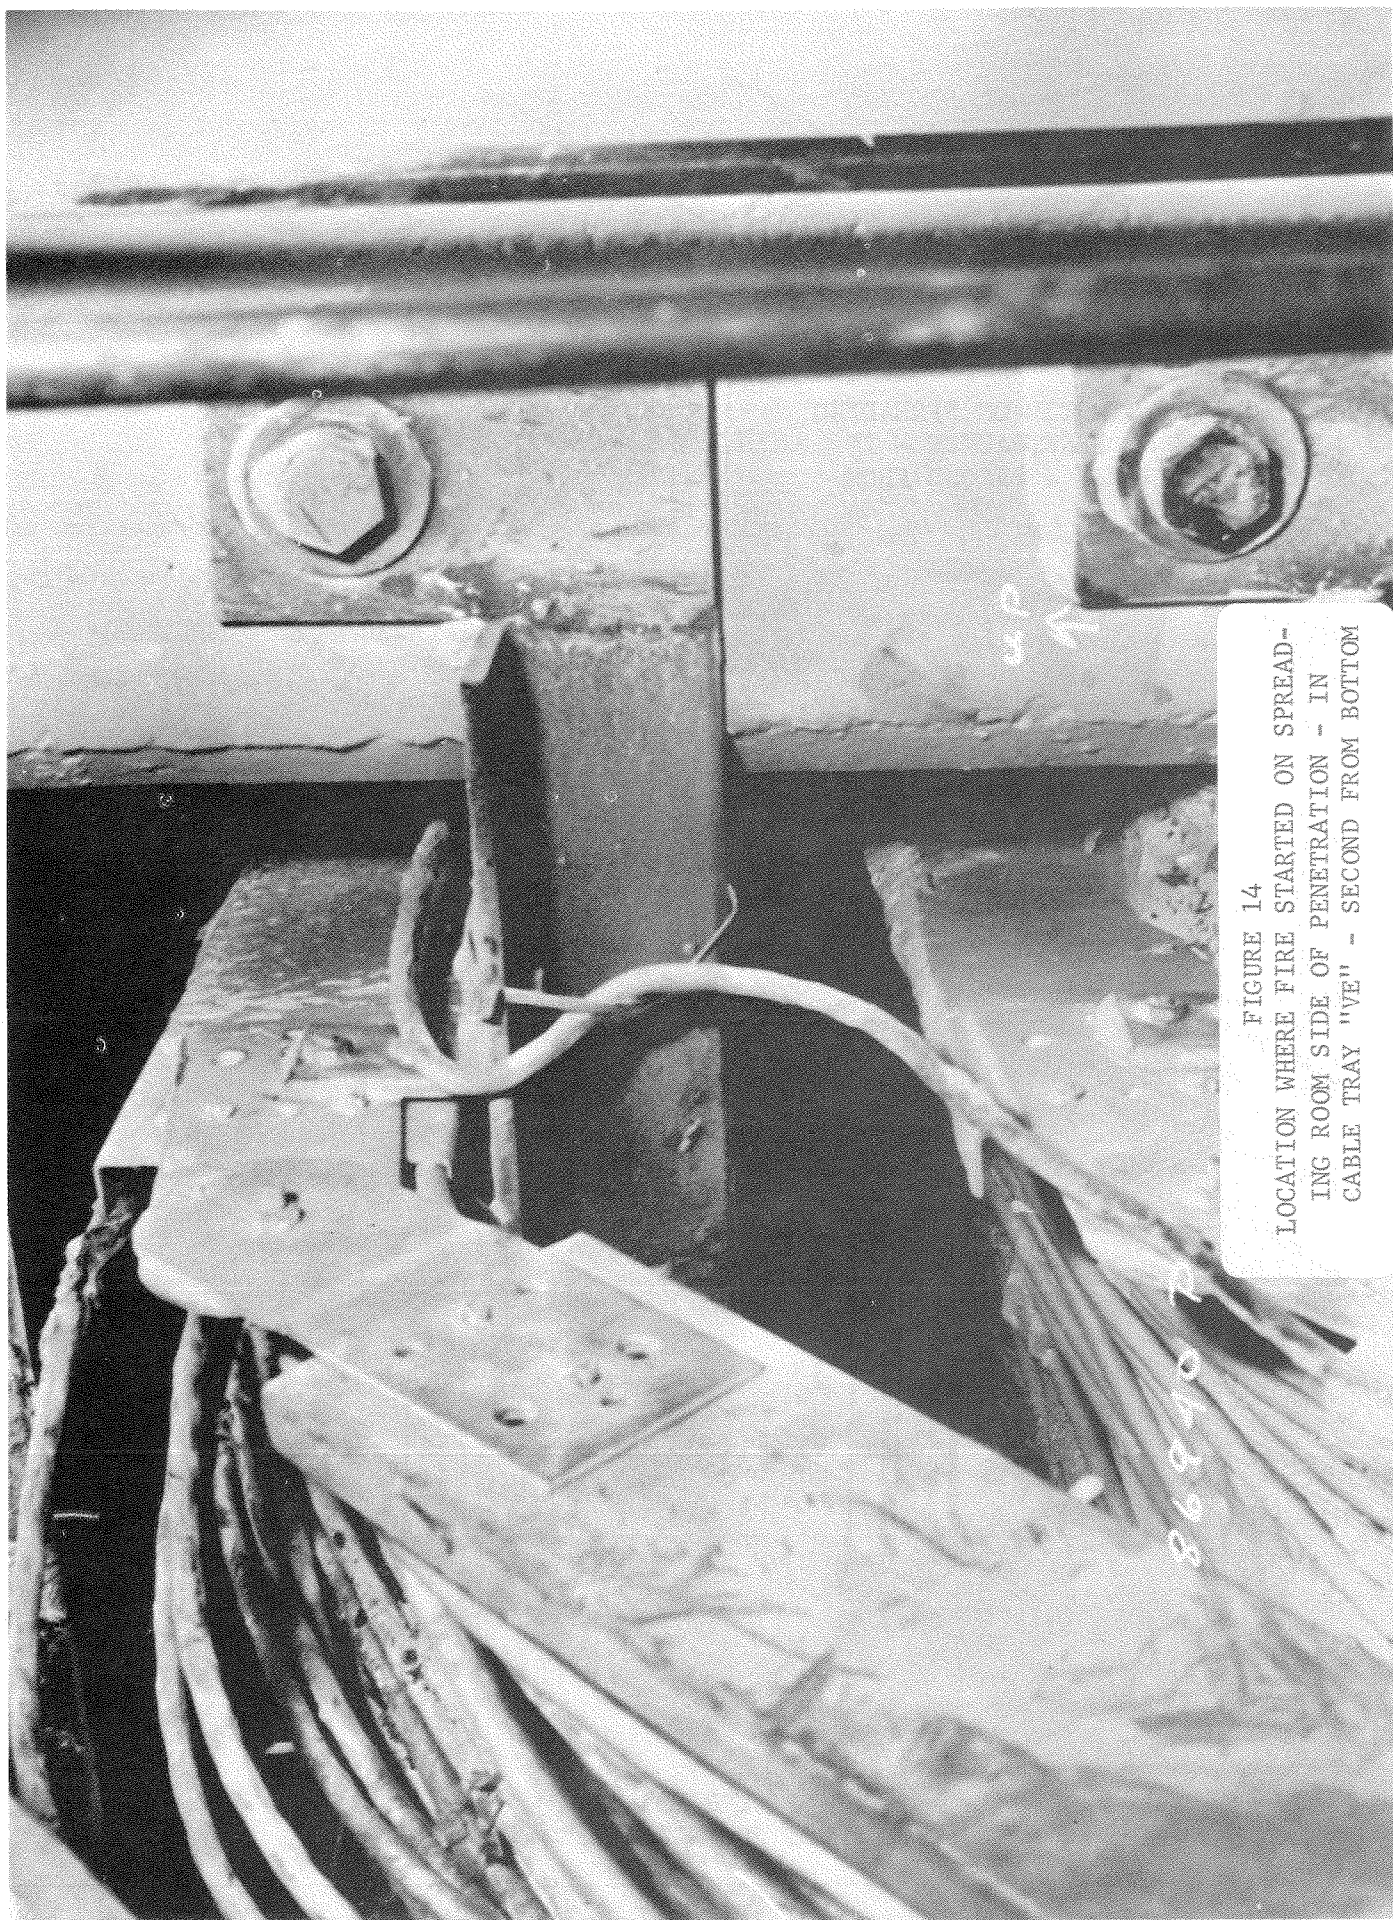
FIGURE 14
LOCATION WHERE FIRE STARTED ON SPREAD-
ING ROOM SIDE OF PENETRATION - IN
CABLE TRAY "VE" - SECOND FROM BOTTOM

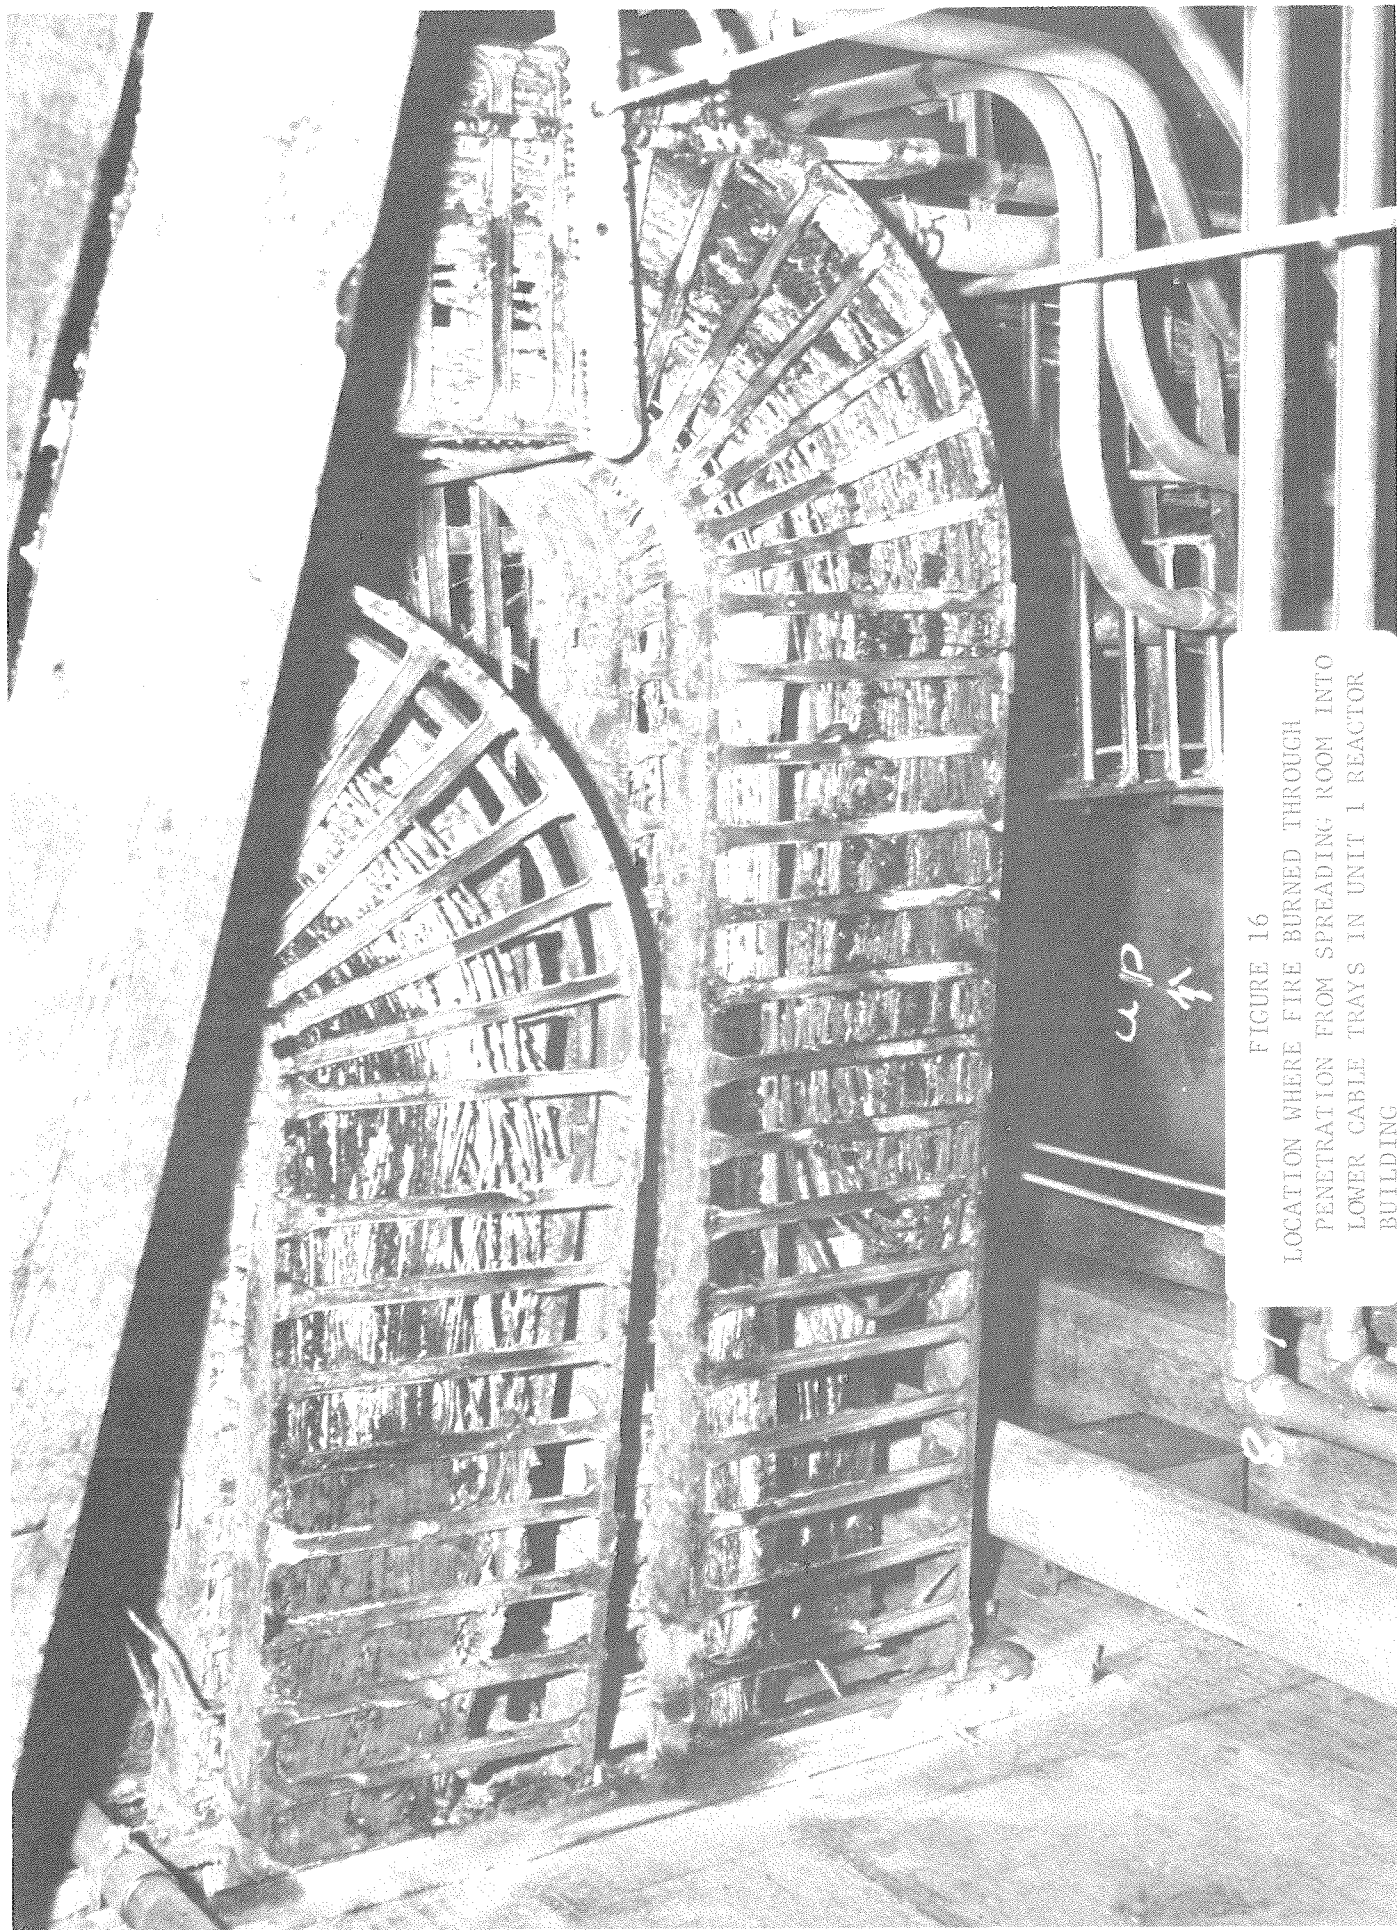
FIGURE 16
LOCATION WHERE FIRE BURNED THROUGH
PENETRATION FROM SPREADING ROOM INTO
LOWER CABLE TRAYS IN UNIT 1 REACTOR
BUILDING

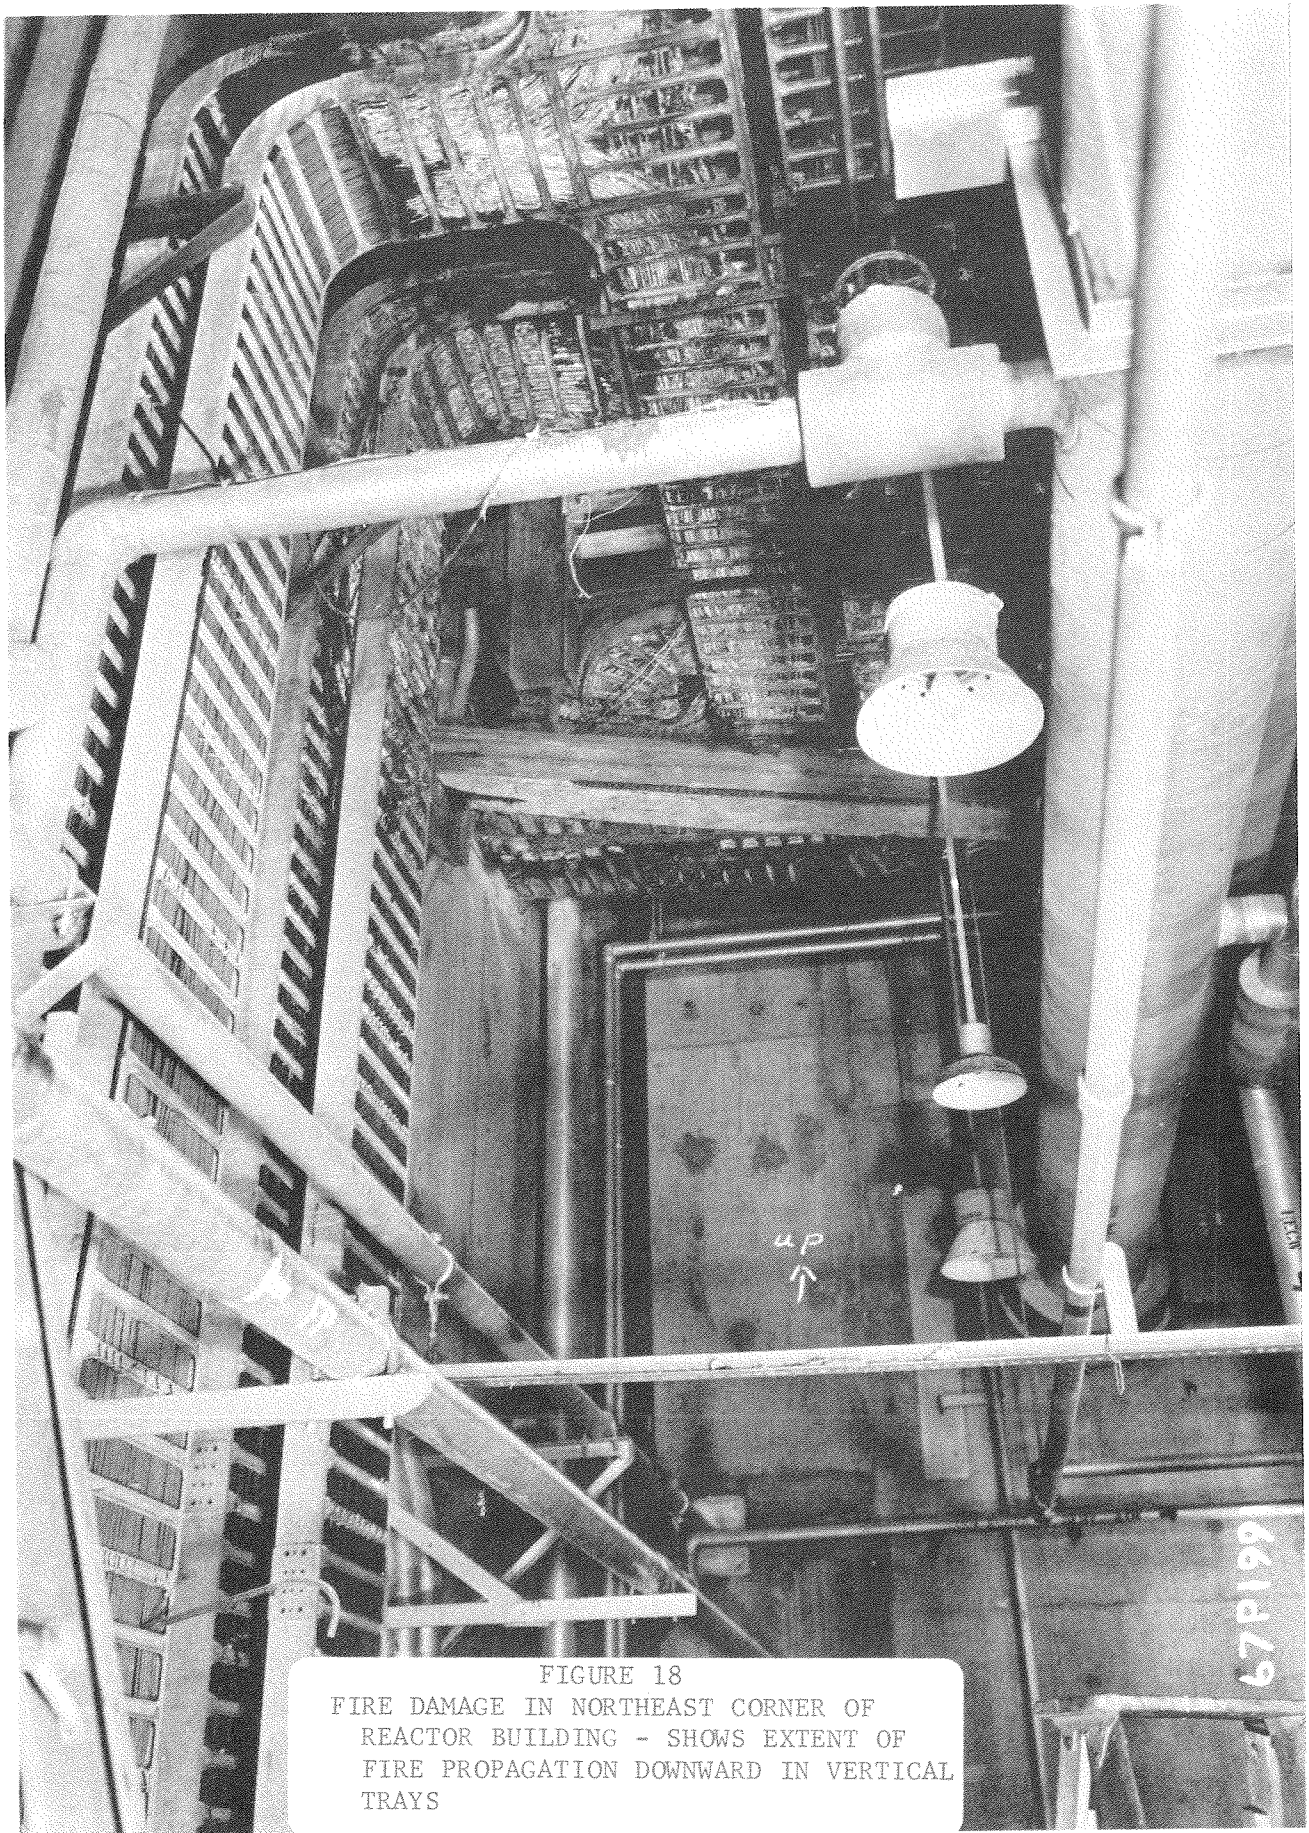
FIGURE 18
FIRE DAMAGE IN NORTHEAST CORNER OF
REACTOR BUILDING - SHOWS EXTENT OF
FIRE PROPAGATION DOWNWARD IN VERTICAL
TRAYS

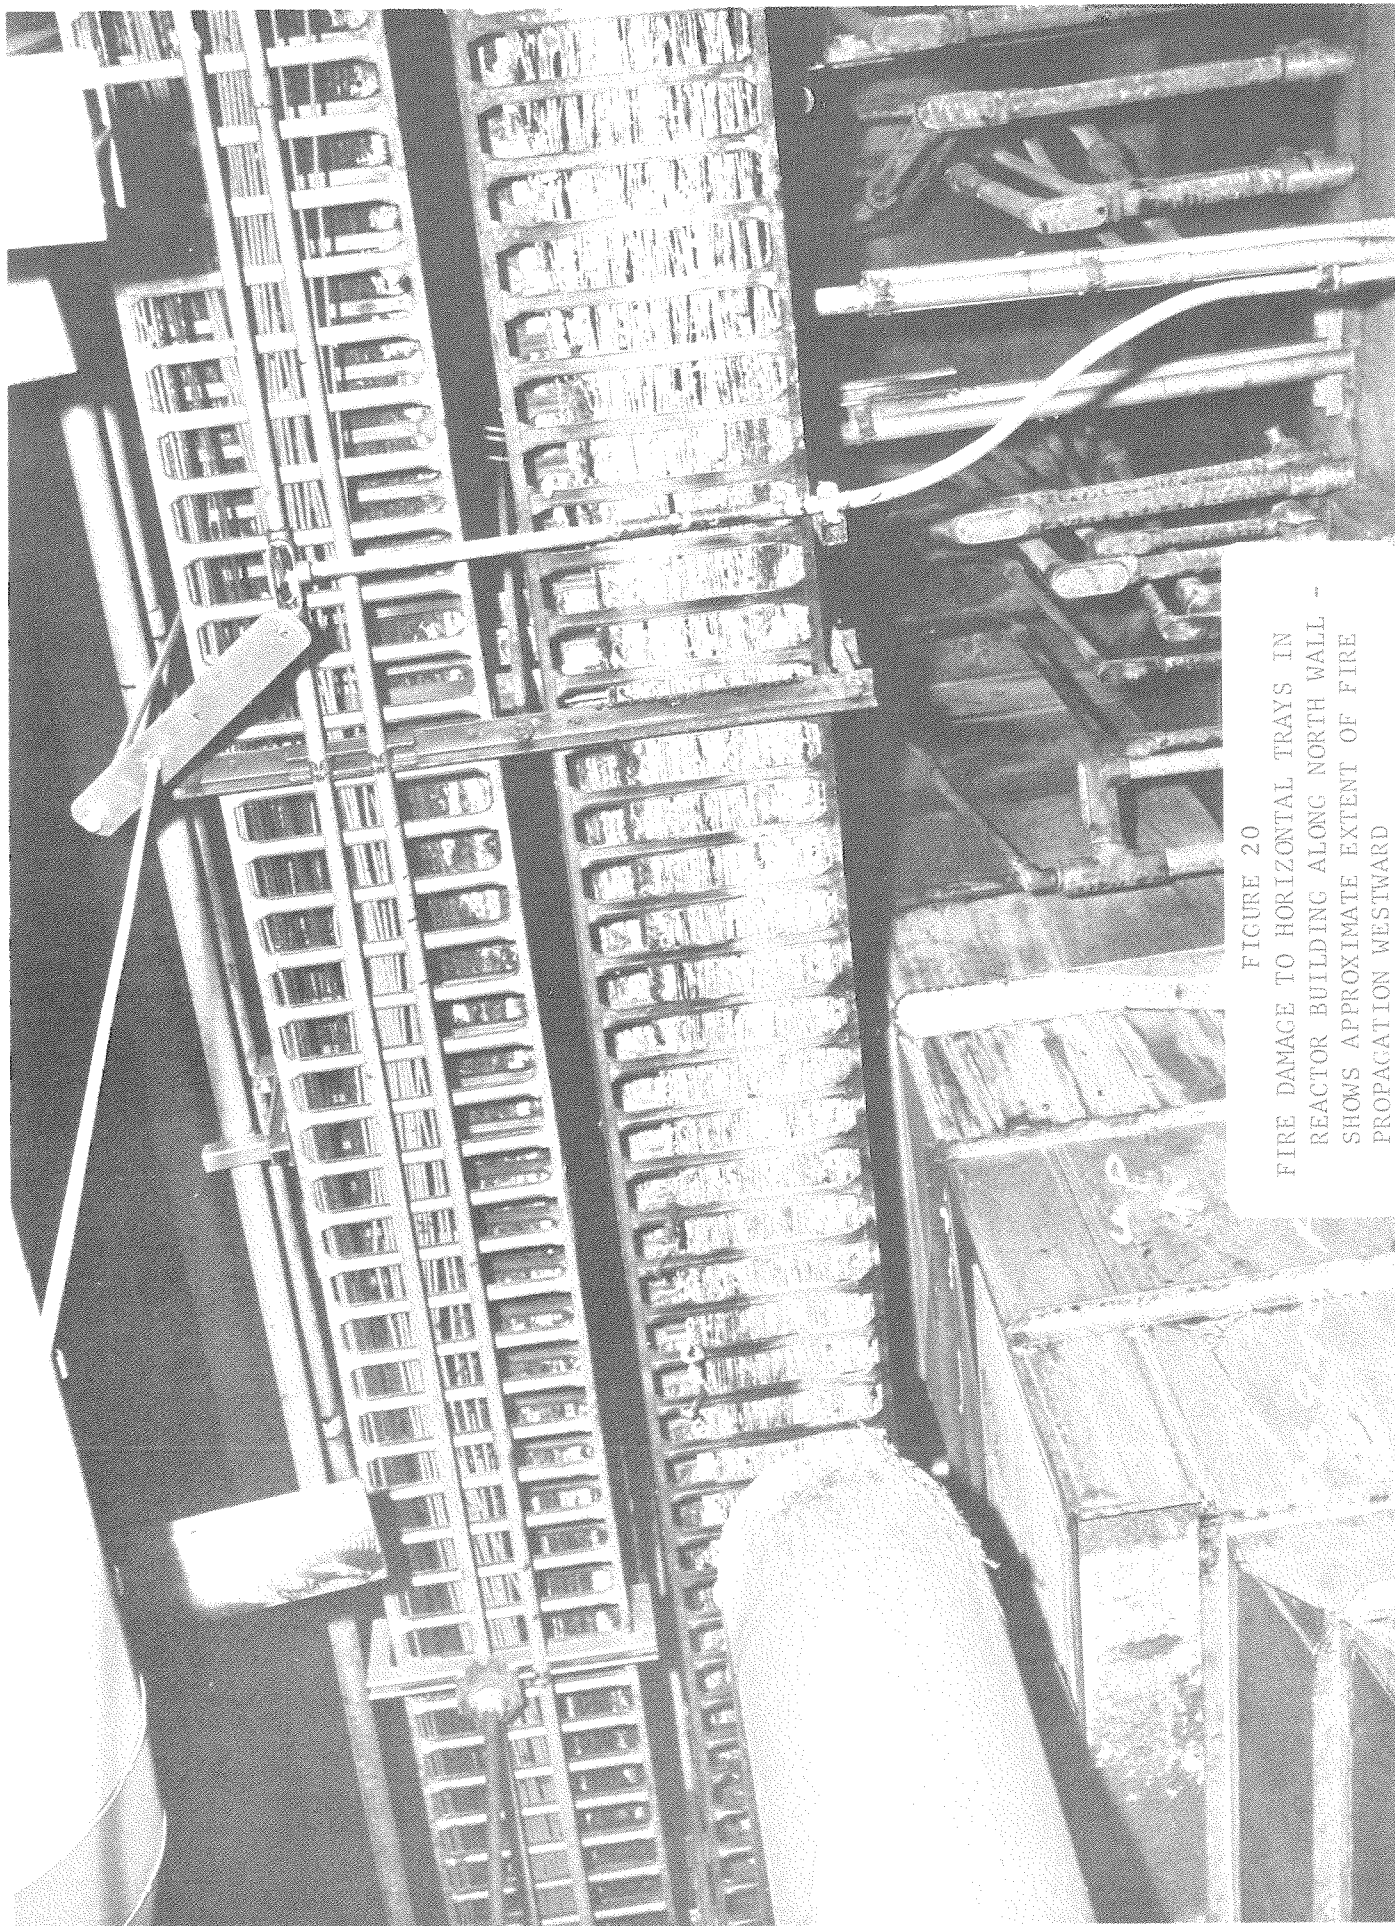
FIGURE 20
FIRE DAMAGE TO HORIZONTAL TRAYS IN
REACTOR BUILDING ALONG NORTH WALL -
SHOWS APPROXIMATE EXTENT OF FIRE
PROPAGATION WESTWARD

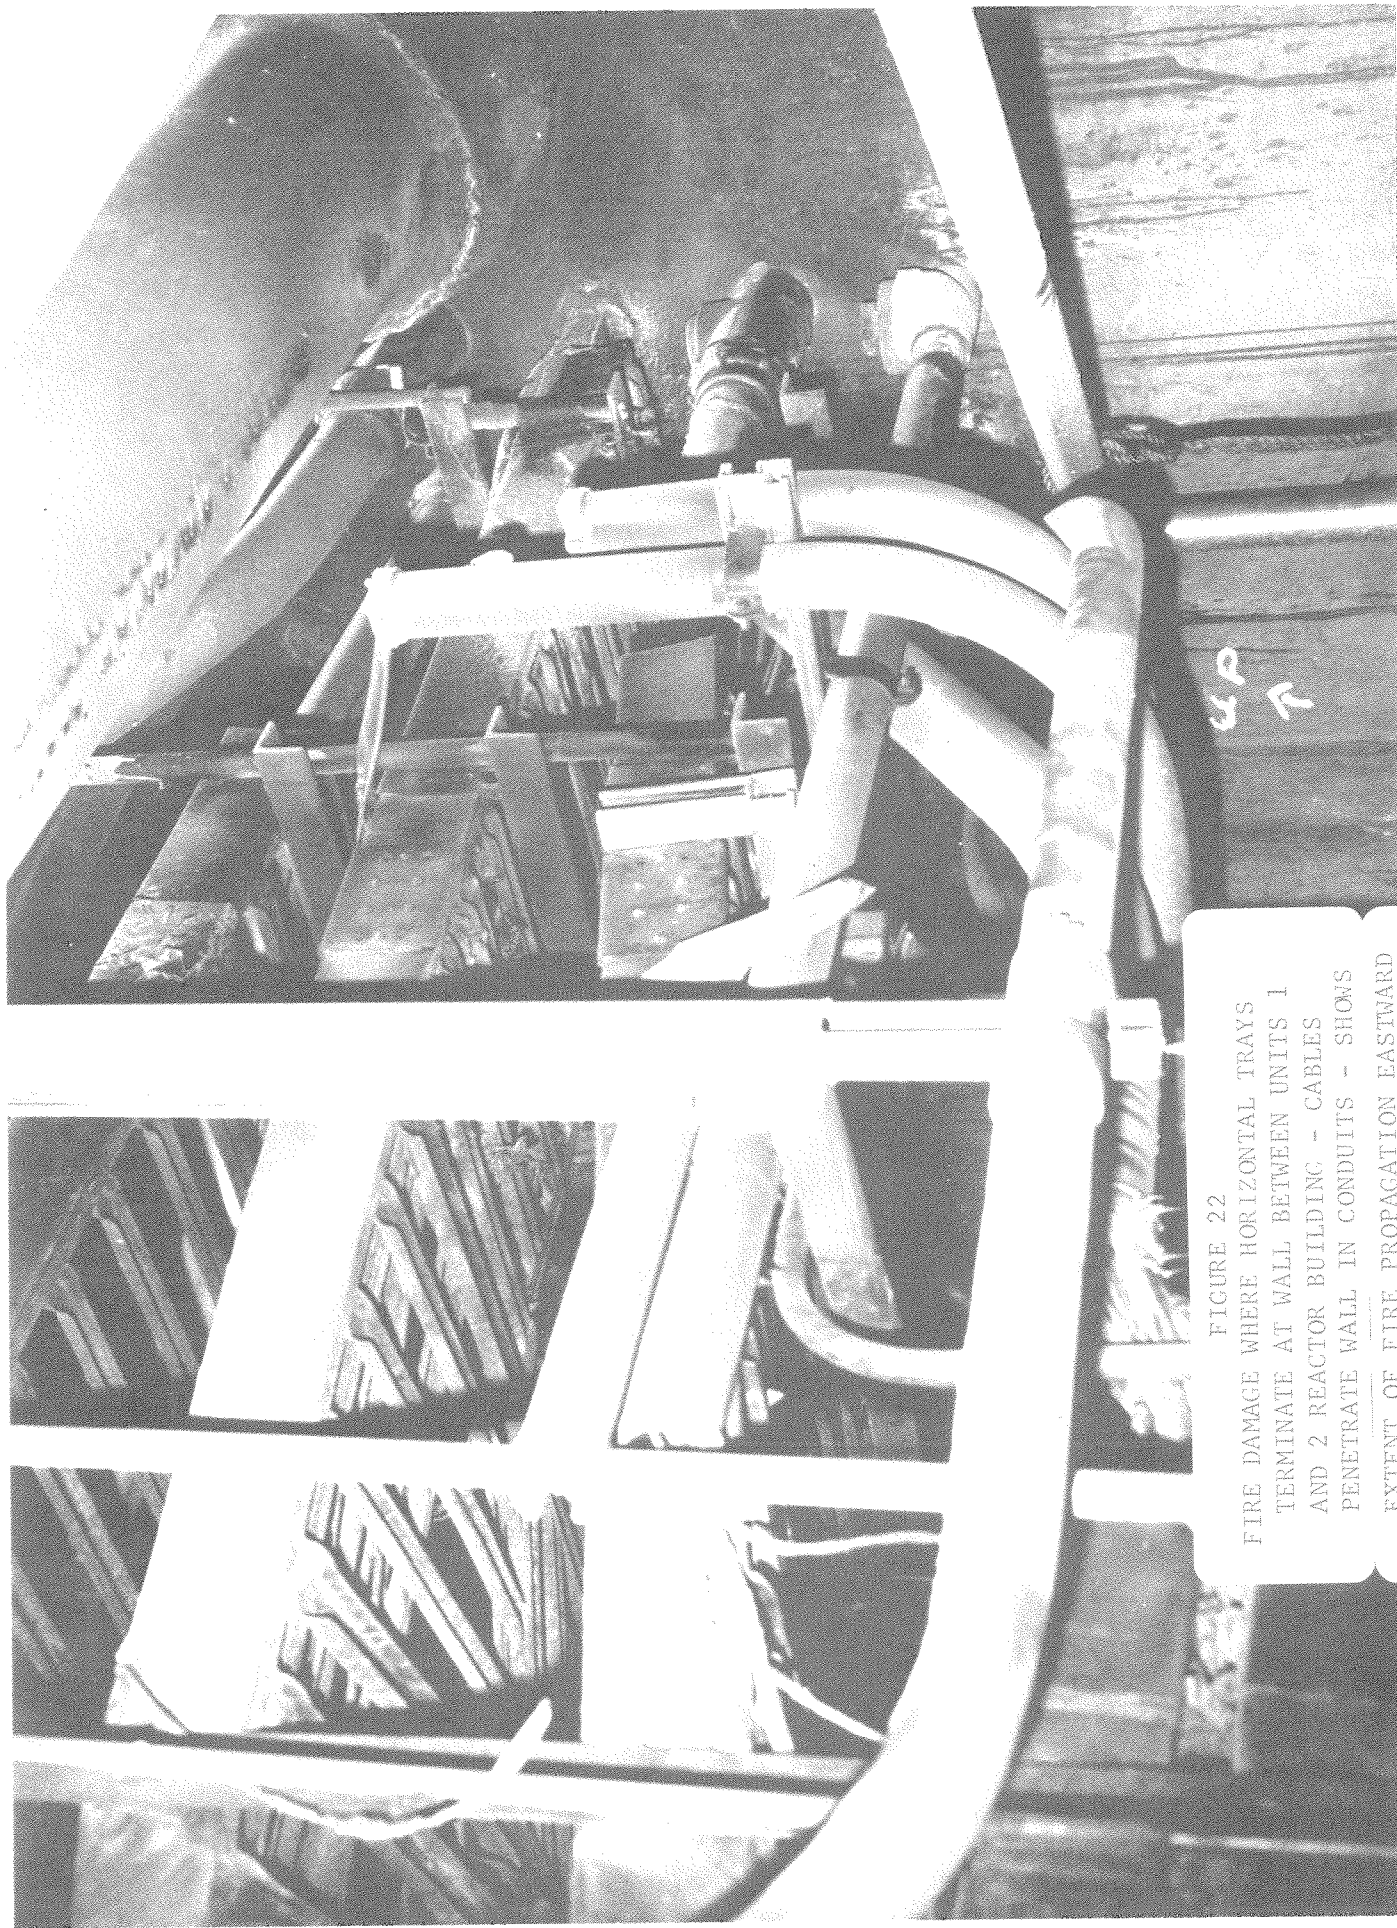
FIGURE 22
FIRE DAMAGE WHERE HORIZONTAL TRAYS
TERMINATE AT WALL BETWEEN UNITS 1
AND 2 REACTOR BUILDING - CABLES
PENETRATE WALL IN CONDUITS - SHOWS
EXTENT OF FIRE PROPAGATION EASTWARD

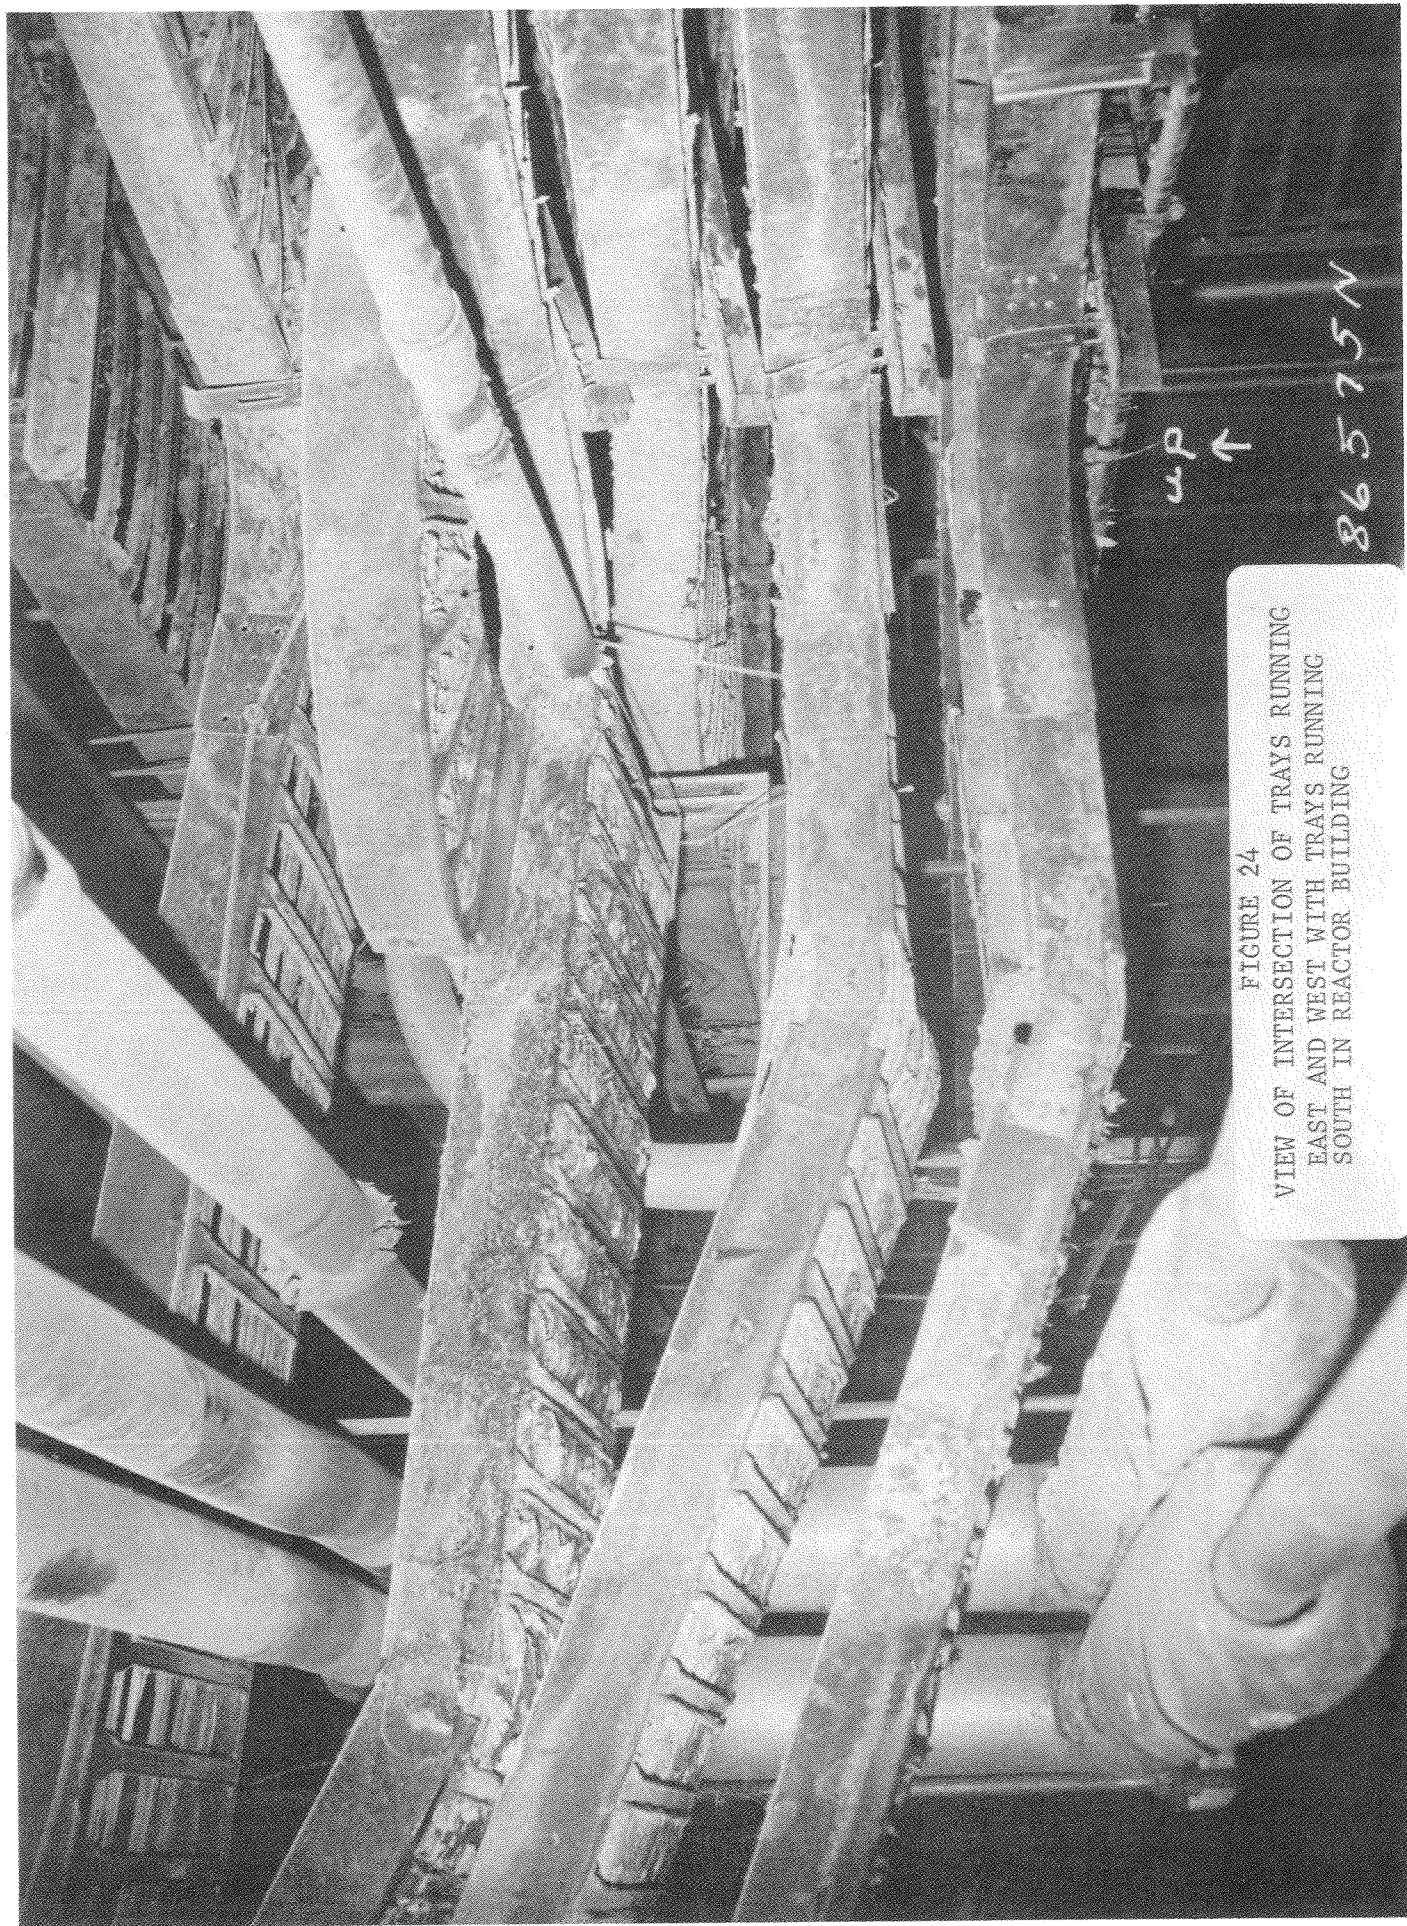
FIGURE 24
VIEW OF INTERSECTION OF TRAYS RUNNING
EAST AND WEST WITH TRAYS RUNNING
SOUTH IN REACTOR BUILDING
